## **BBN Technical Memorandum No. 1270**

### **ANIMIDA Phase I: Ambient and Industrial Noise Measurements Near the Northstar and Liberty Sites During April 2000**

**Arctic Nearshore Impact Monitoring in the Development Area  
(ANIMIDA)**

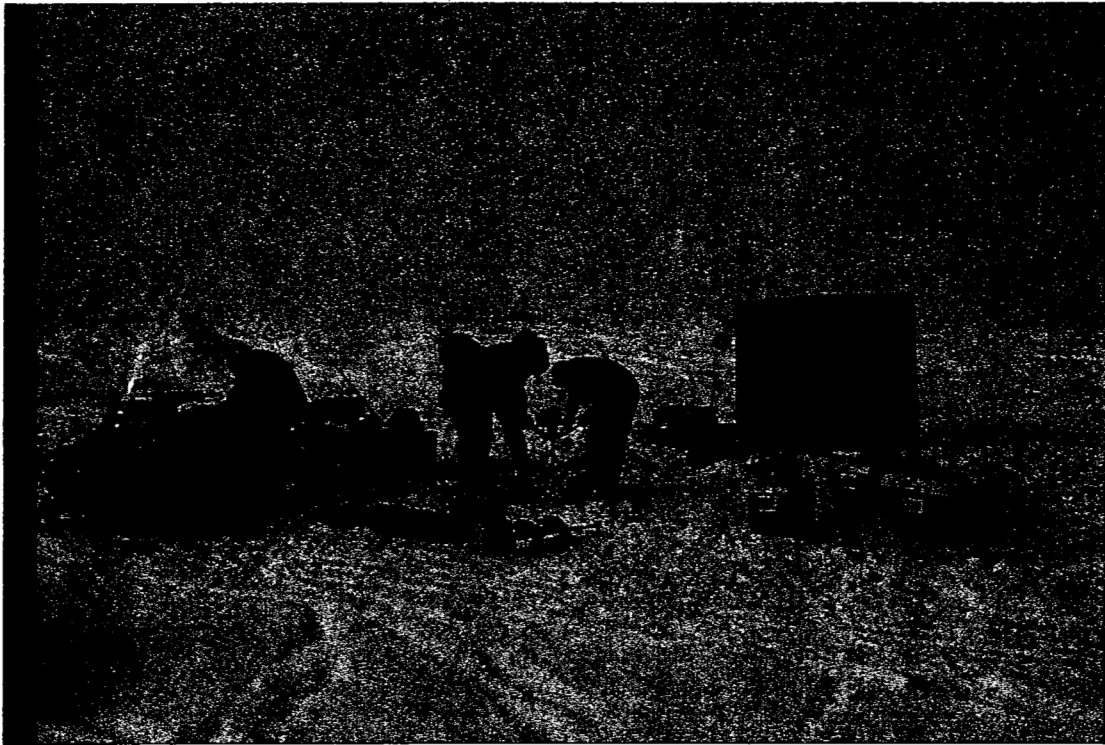
**Figure 2- 3. Photograph of site NA3 preparations.**

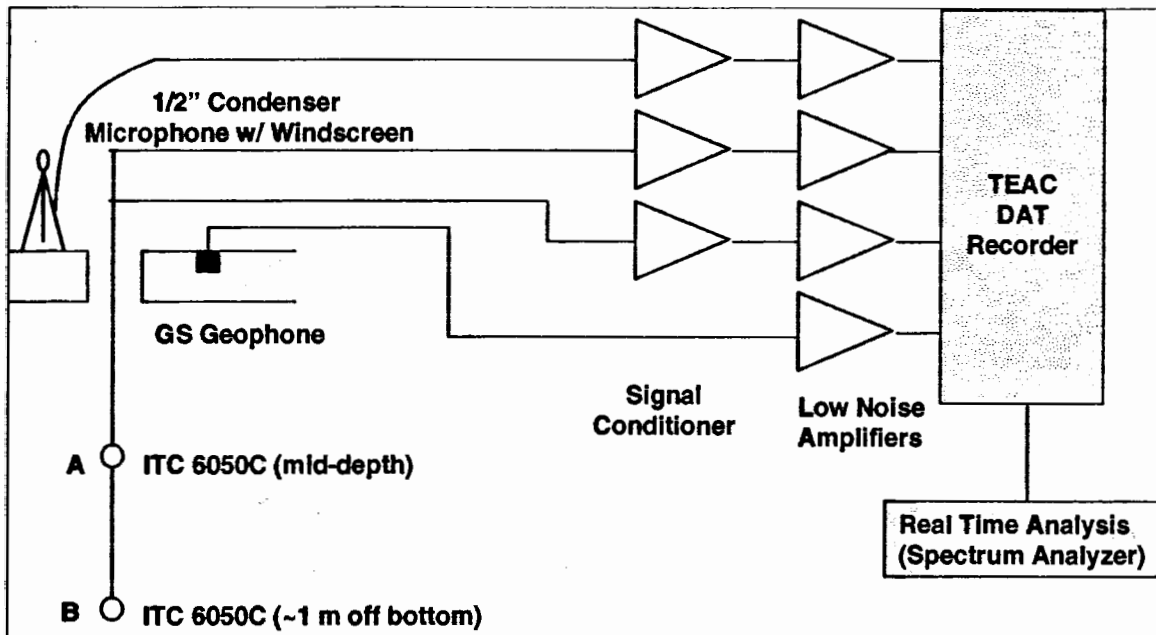
Figure 2- 4. Acoustic and vibration measurement system.

The two hydrophones were deployed through a hole in the ice. Hydrophone #1 was installed at a depth within 6.5 ft (2 m) of the bottom. Hydrophone #2 was lowered to a mid water column depth. The signals from each hydrophone were passed through a signal conditioning amplifier with a gain of 0 dB for impedance matching and then amplified using a BBN manufactured (Model 392) low noise amplifier whose gain varied from site to site as the noise conditions warranted. Amplifier gains for all channels and measurement sites are documented in Table 2-2.

The microphone was a calibrated  $\frac{1}{2}$ -inch Genrad Condenser microphone with a sensitivity of  $-134$  dBV re  $20 \mu\text{Pa}$  over the frequency band from 15 Hz to 19 kHz. The

geophone was a Geo Space model GS-32CT close tolerance geophone. Its intrinsic voltage sensitivity was 0.698 V/in/sec and its sensitivity at 70% damping was 0.500 V/in/sec. The microphone signal was passed through a 0 dB gain signal conditioner and both sensors were amplified using BBN's 392 low noise amplifiers. As with the hydrophones, noise floors were measured in the laboratory and are presented in Figure 2-6.

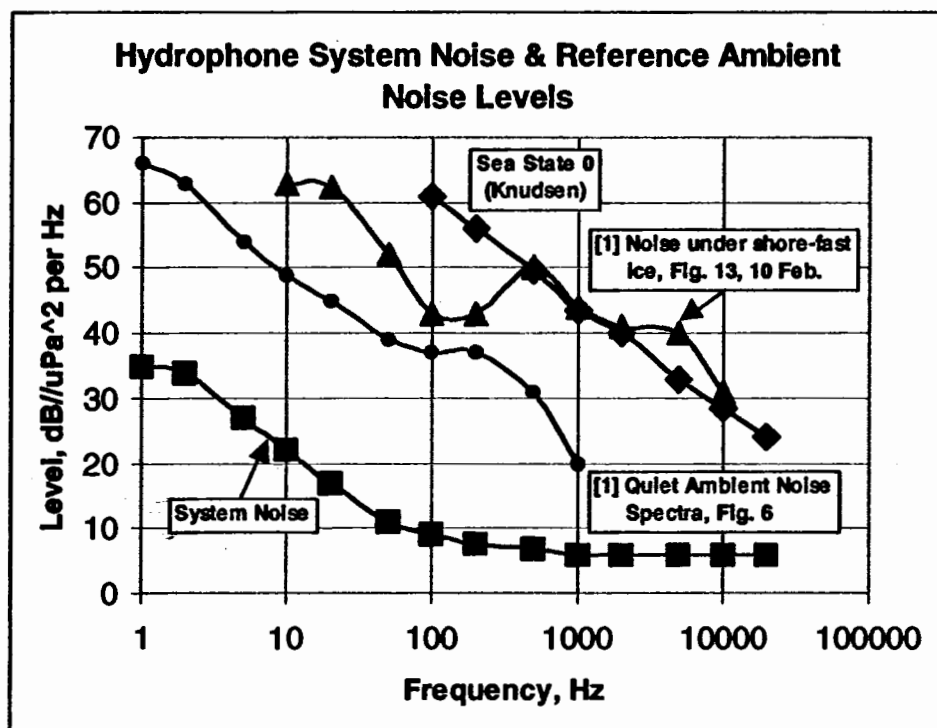
Figure 2- 5. Hydrophone system characteristics.

The hydrophones were both ITC Type 6050C calibrated sensors each with a nominal sensitivity of  $-161$  dBV re  $1 \mu\text{Pa}$ . In the passband from 2 Hz to 20 kHz, the sensitivity ripple was  $\pm 0.8$  dB. System electronic noise was measured in the laboratory by shorting out the channel input and recording the resulting noise through the system and onto the DAT recorder which was subsequently analyzed to define the noise floor. Figure 2-5 compares the measured noise floor with historical Arctic and open water noise spectra.

In general, the noise environment at site NA2 showed hardly any apparent manmade noise contamination. Two samples of underwater noise spectra, shown in Figures 3.1.3-1 and 3.1.3-2, are quite close to the conditions measured in [1] under quiet ambient conditions (see Figure 2-5) and is approximately 12 dB lower than Knudsen's sea state zero [2]. No narrowband tonals are present and the 1/3 OB levels at both water depths are nearly identical. There is a small energy peak in the mid channel hydrophone near 20 Hz whose source is unknown but may be produced by the ice; see the geophone data below.

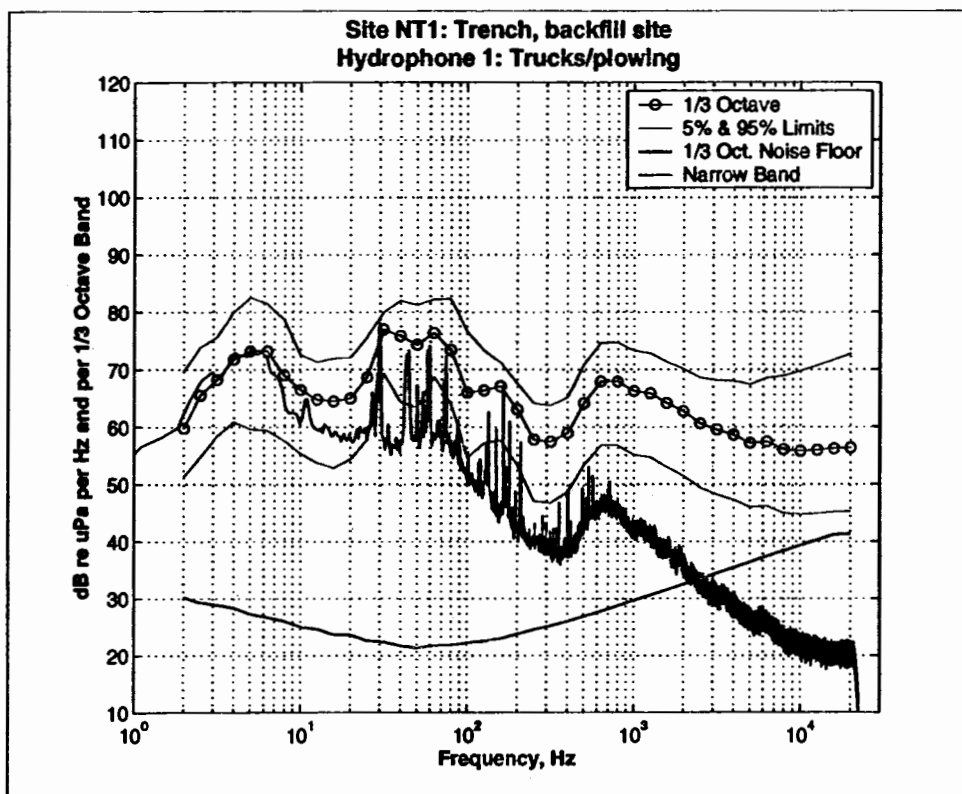
Figure 3.1.1- 1. Near-bottom underwater Noise near Northstar ice road (2-2700).

Underwater noise spectra from the near bottom hydrophone (labeled #1) is presented in Figure 3.1.1-1 and the mid water hydrophone (labeled #2) in Figure 3.1.1-2. The amplifier gains for both sensors were set at 30 dB. Hydrophone #1 (H1) was deployed at a depth of 26 ft (8 m) and hydrophone #2 (H2) at 16.5 ft (5 m). The water depth was 32 ft (9.7 m). Both sensors show a rich tonal structure above 25 Hz and below 600 Hz with H1, the deeper sensor, having higher level tonals. The source of the broad spectral peak near 700 Hz is unknown and was not observed at the other locations. However, it is also present in the microphone data discussed below. Field personnel noted “gurgling” water sounds at this site but it is not clear if this was the source of the spectral peak.

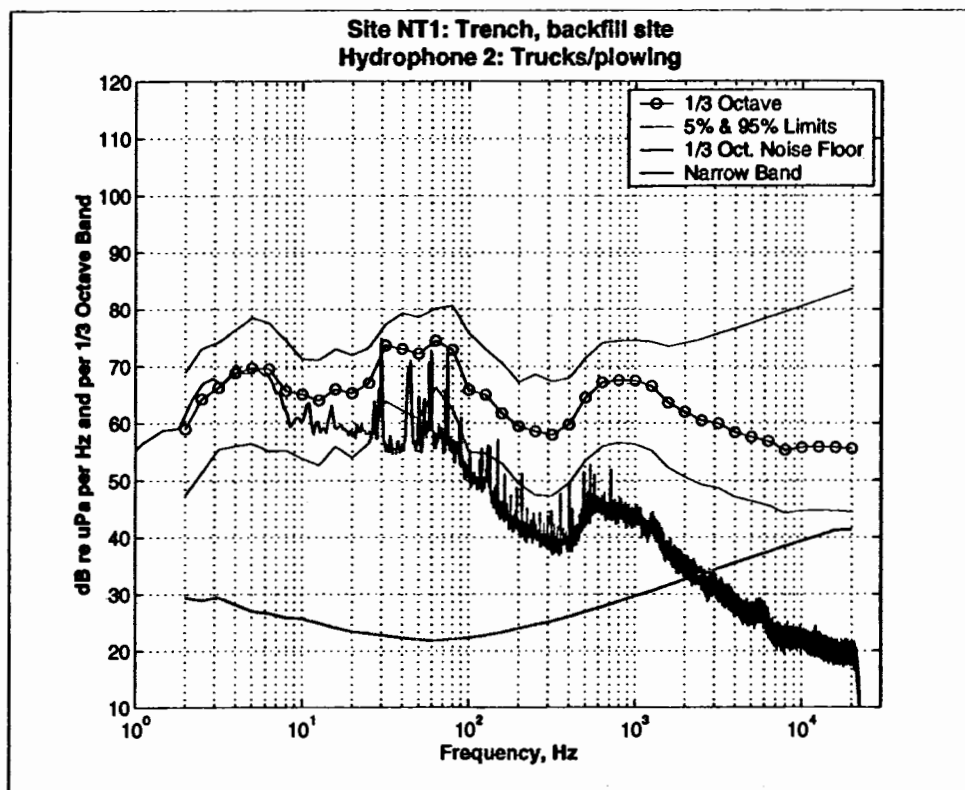
Figure 3.1.1- 2. Mid depth underwater Noise near Northstar ice road (2-2700).

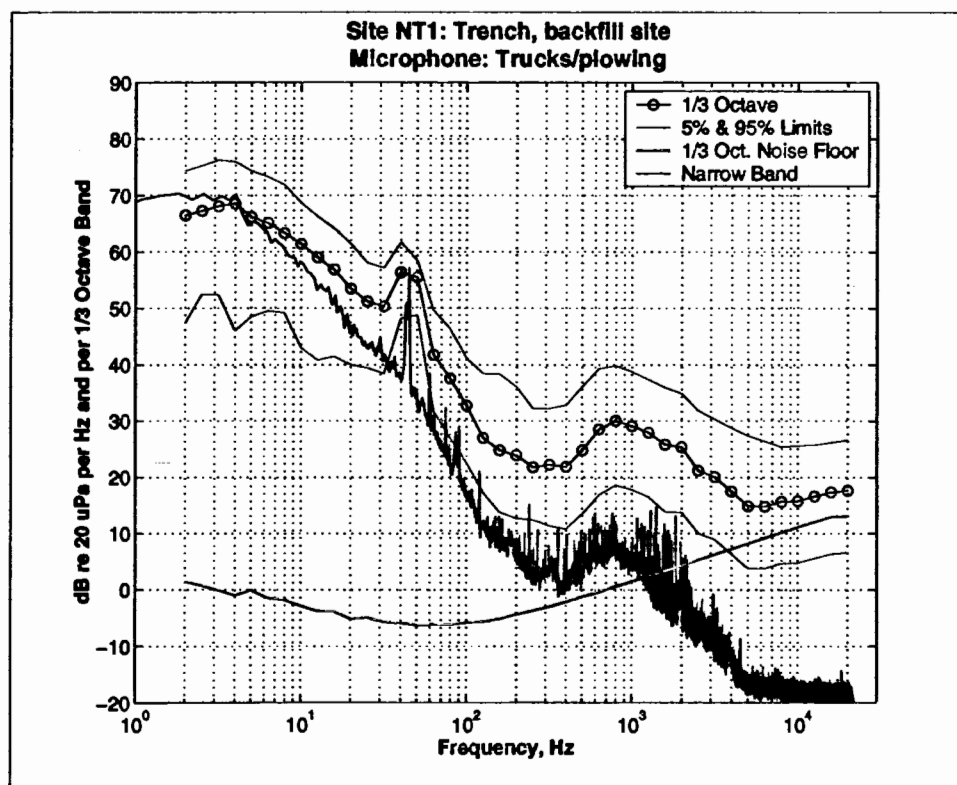
Figure 3.1.1- 3. Airborne noise near Northstar ice road (2-2700).

Above 5 kHz, the noise level is approaching the noise floor of our measurement system. Some of the same tonals seen underwater are present in the air such as near 44 Hz and at 350 and 400 Hz. But the dominant feature is the broadband low frequency noise. Compared to measurement made near Liberty in a very quiet environment (for example, see Section 3.2.1), the airborne noise here is 10 to 25 dB higher at frequencies below 200 Hz.

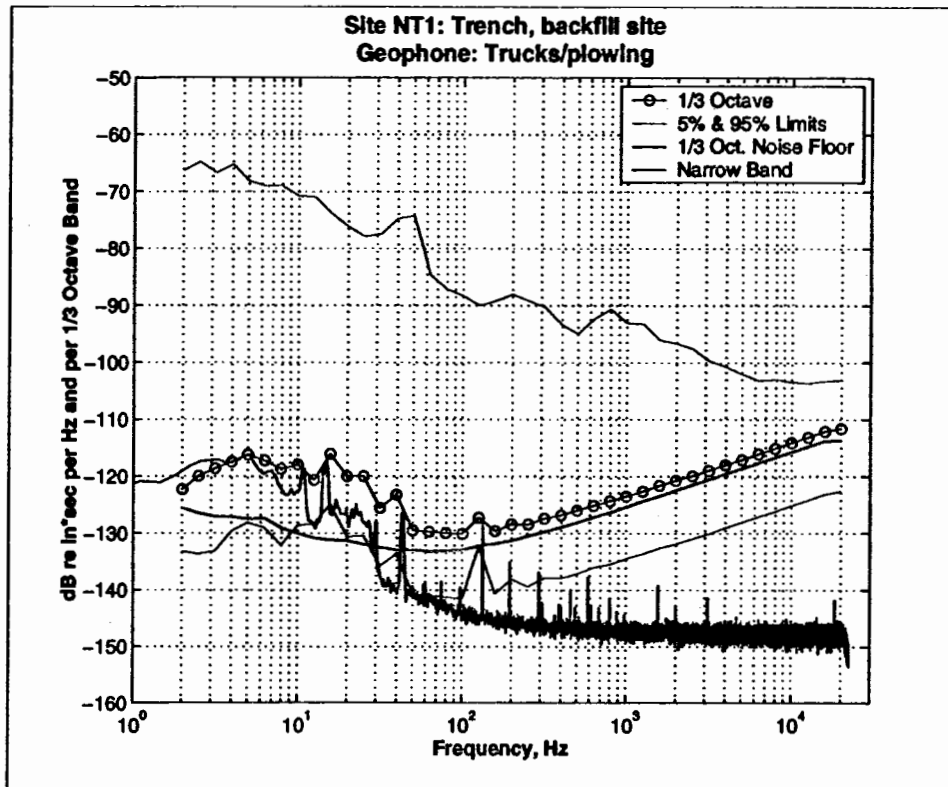
Figure 3.1.1- 4. Measured ice vibration levels near Northstar ice road (2-2700).

Figure 3.1.1-4 shows the measured ice vibrations at the NS-Trench1 site. In general, the levels are quite low with most of the energy in the band from 2 to 40 Hz. Some narrowband tonals can be seen above the noise up to a few kHz. The most significant feature is the high level of the 95<sup>th</sup> percentile noise. This indicates multiple short duration or bursts of high level vibrations in the data segment. Its broadband nature is consistent with impulsive noise most likely due to the bangs associated with plowing and dumping operations.

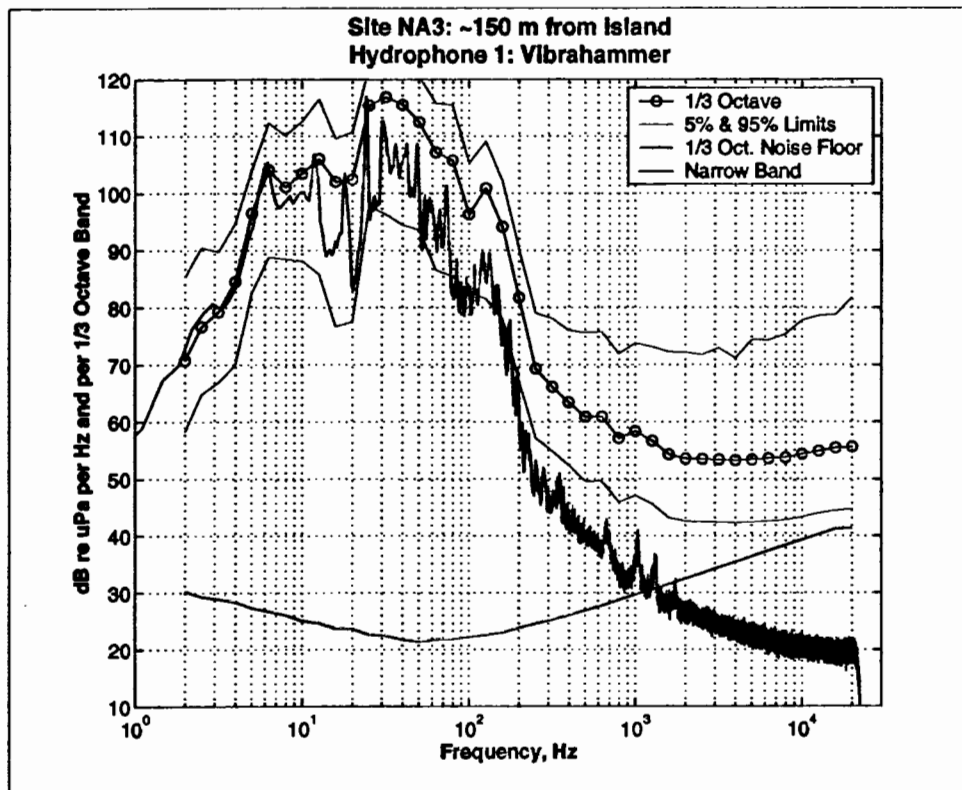
**Figure 3.1.2- 1. Near-bottom underwater noise at Site NA3 (3-4610).**

Figures 3.1.2-1 and 3.1.2-2 present the strongest underwater noise levels collected during vibrahammer operation. Amplifier gains were set at 30 dB. With H1 suspended at a depth of 33 ft (10 m) and H2 at a mid channel depth of 20 ft (6 m), the near-bottom sensor exhibits higher level noise than the mid-channel hydrophone because of its proximity to the bottom from which we believe the noise is primarily radiating. The spectral characteristics of vibrahammer noise include a strong tonal at 23 Hz, a broad level peak in the 2 to 15 Hz band. A second broad peak centered at 30 Hz, and a steep roll-off of energy above about 80 Hz. Above 1 kHz, except for the few peaks, the noise is generally consistent with the quiet conditions measured near the Liberty site.

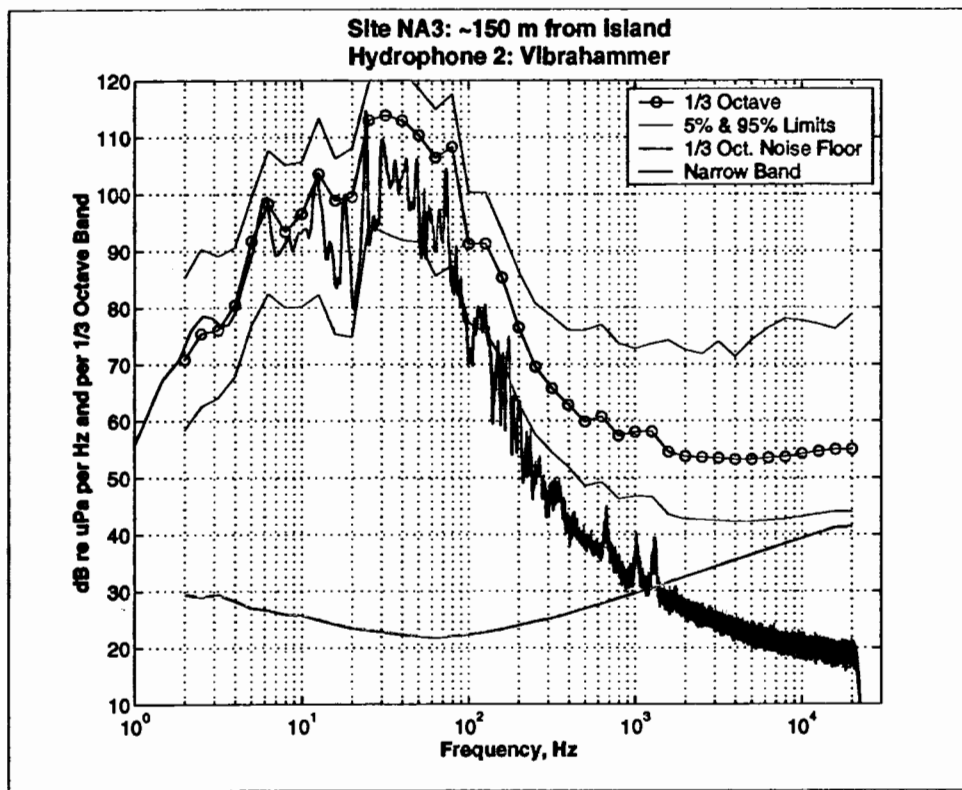
**Figure 3.1.2- 2. Mid channel depth underwater noise at Site NA3 (3-4610).**

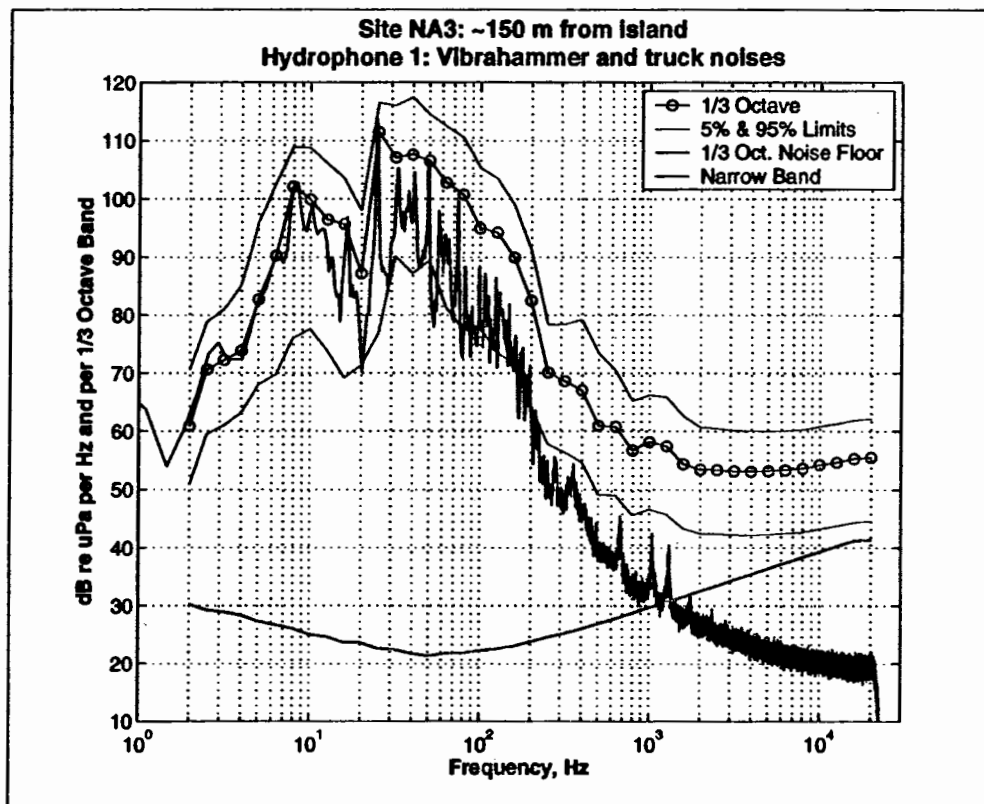
Figure 3.1.2- 3. Near bottom underwater noise at Site NA3 (3-1315).

A second set of vibrohammer underwater noise measurements is shown in Figures 3.1.2-3 (near bottom sensor) and 3.1.2-4 (mid depth sensor). The spectral characteristics are consistent with the previous set except the levels are roughly 2-5 dB lower. This variability should be expected as the coupling of energy into the ground (and thereafter into the water) depends on soil conditions at each sheet piling and how the vibrohammer is attached to the sheet piling. The higher frequency energy peaks at 700 Hz, 1 kHz, and 1.3 kHz in this example have generally higher levels and are due to the vibrohammer operation as they do not appear in any other data set.

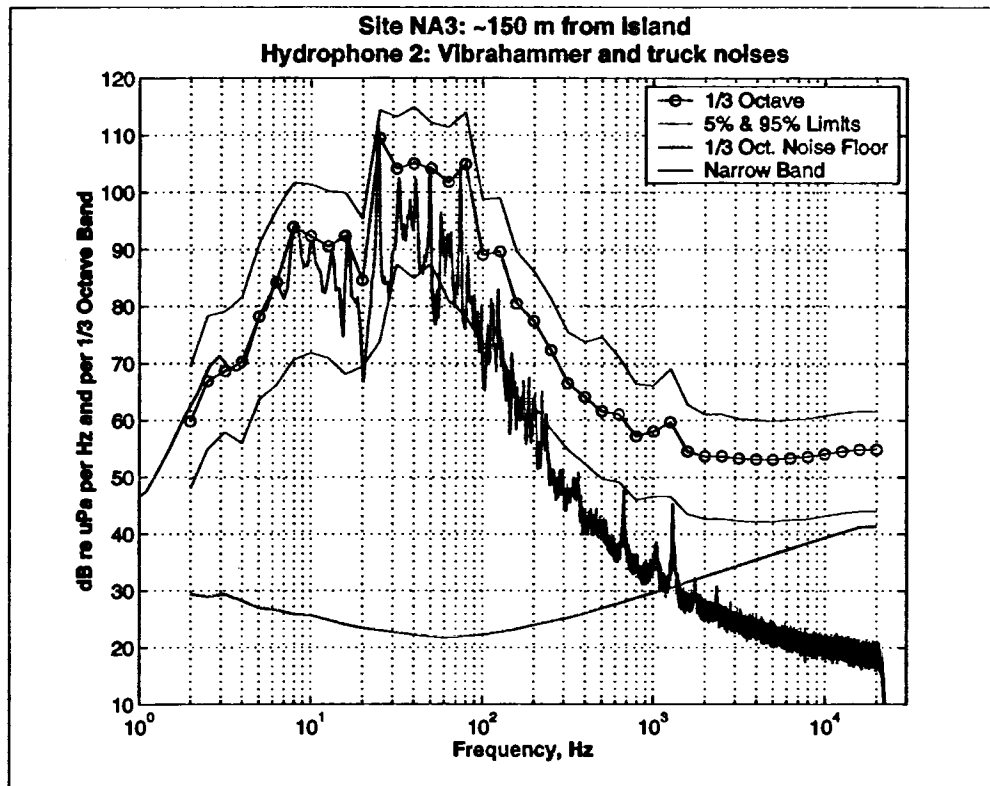
**Figure 3.1.2- 4. Mid channel depth underwater noise at Site NA3 (3-1315).**

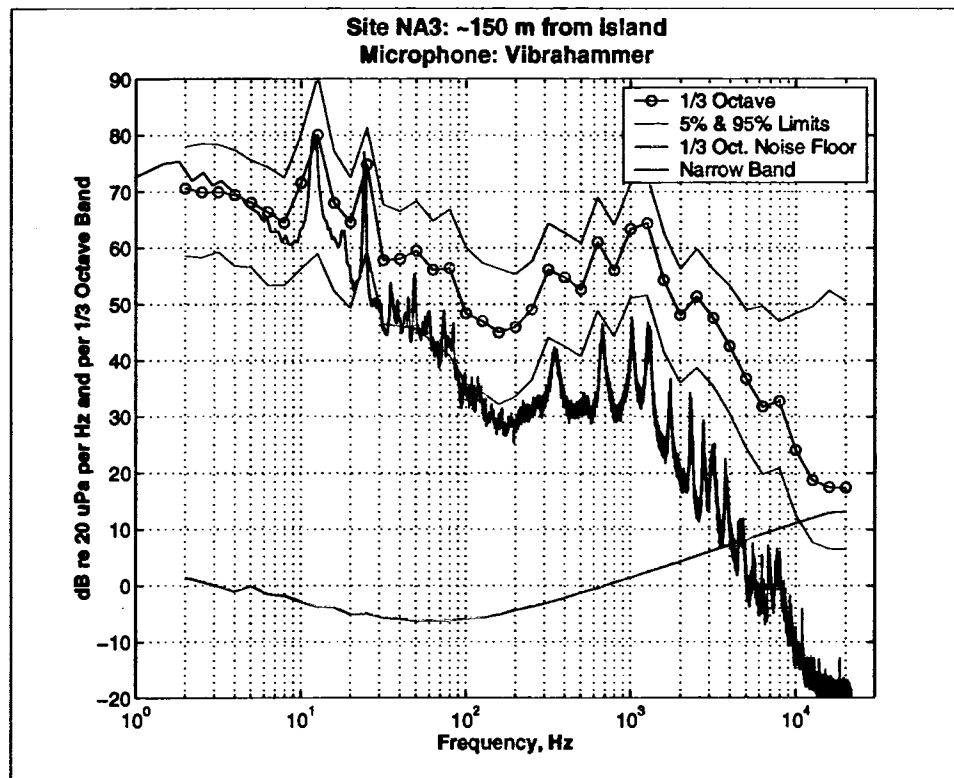
**Figure 3.1.2- 5. Airborne noise at Site NA3 (3-4610).**

Airborne radiated noise from the vibrohammer collected at the same two measurement times are presented in Figures 3.1.2-5 and 3.1.2-6. In the first example, strong peaks dominate the noise environment at 12 and 23 Hz, potentially an harmonically related pair. In the second sample, the 12 Hz contribution has disappeared and the 23 Hz energy is 10 dB lower. As noted above, the differences are thought to be due to the variability in sheet piling coupling to variable soil conditions on the island. In both cases, the vibrohammer dominates nearly the whole the spectrum from 2 Hz up to about 15 kHz.

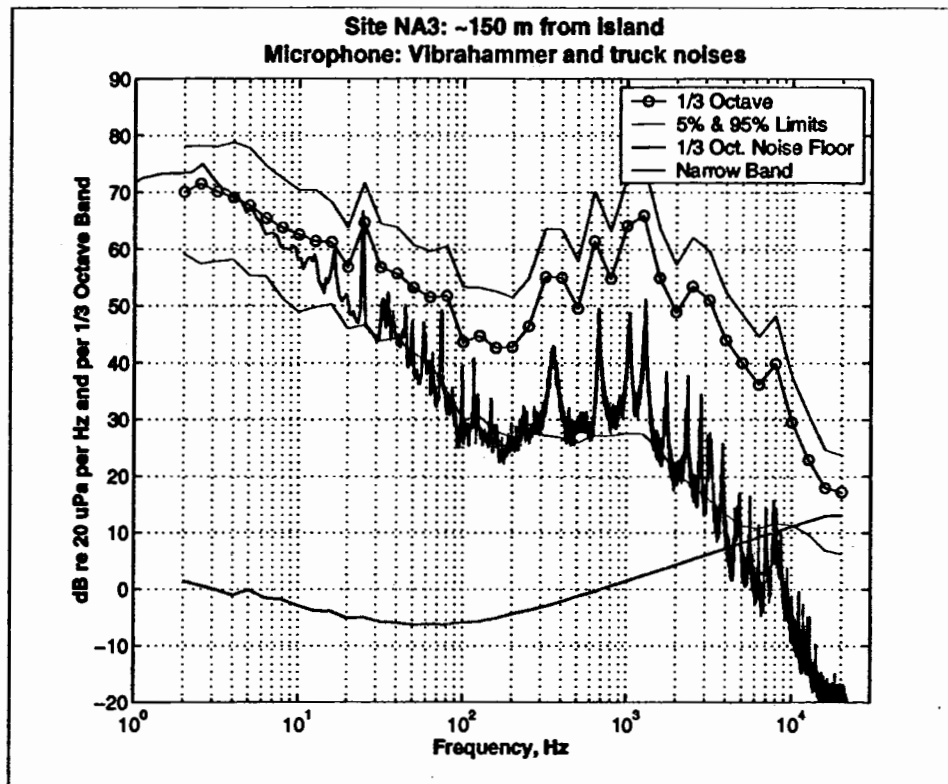
**Figure 3.1.2- 6. Second example of airborne noise at Site NA3 (3-1315).**

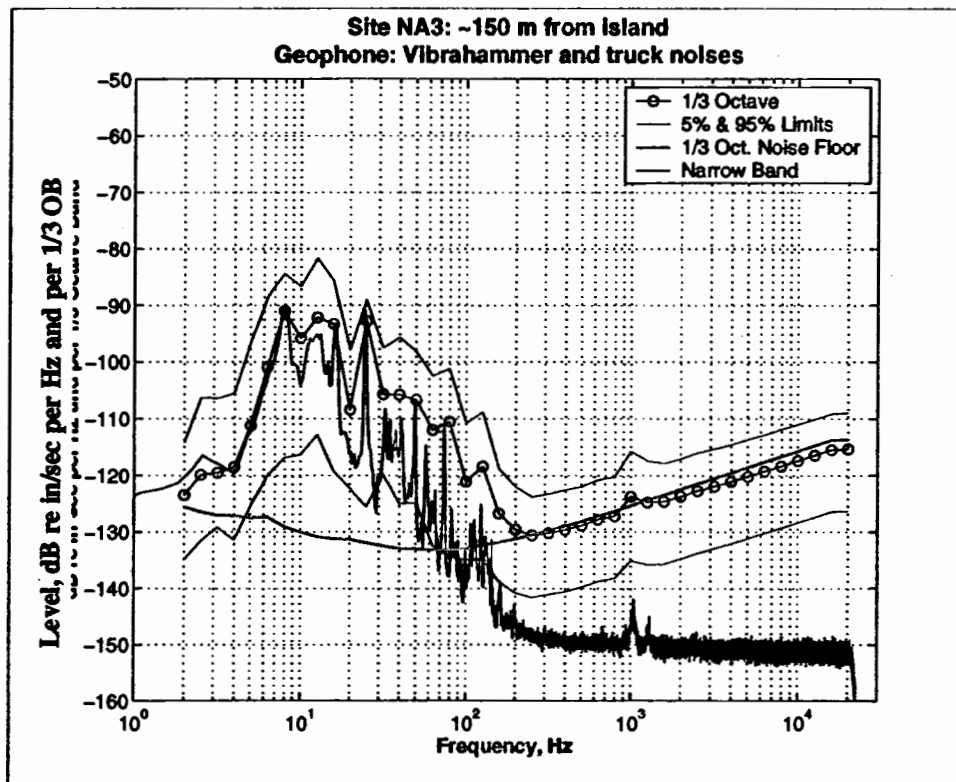
**Figure 3.1.2- 7. Ice vibration levels from vibrahammer at Site NA3 (3-1315).**

Vibrohammer energy is also significant in the ice producing vibrations that can span the 2 Hz to 2 kHz band. Figure 3.1.2-7 provides an example. The characteristic vibrohammer spectral shape seen in the underwater environment is readily apparent. However, only energy below 200 Hz seems to couple well into the ice.

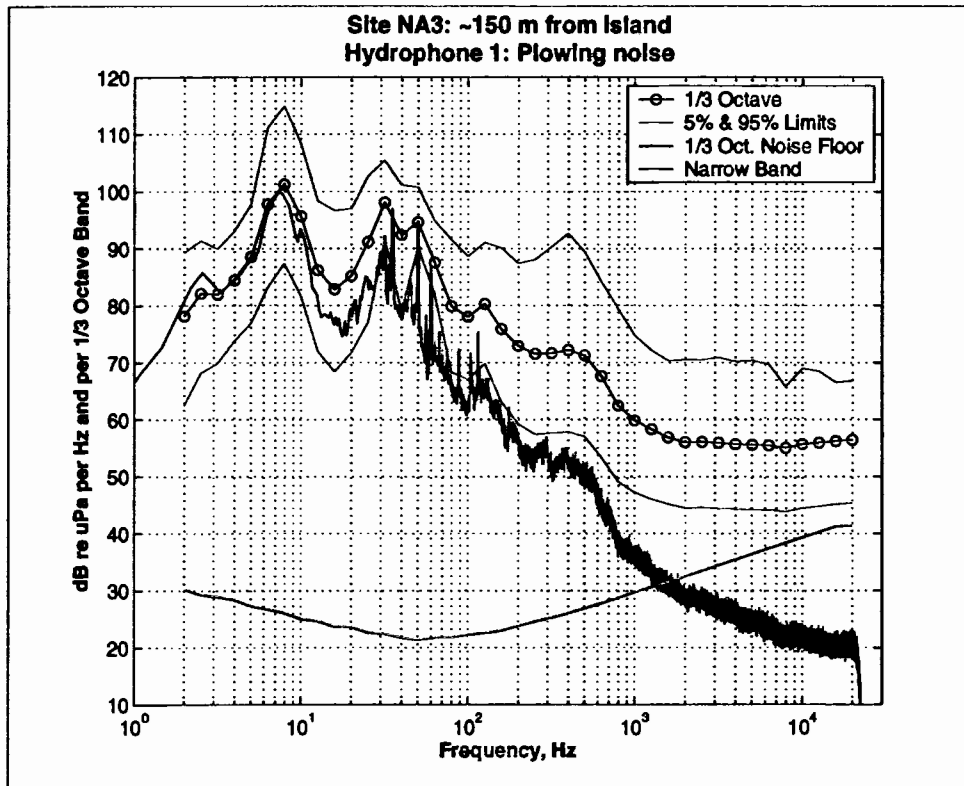
Figure 3.1.2- 8. Near bottom underwater noise at Site NA3, plowing noise (3-8100).

As was observed along the ice road in Section 3.1.1, plows and trucks operated generally continuously. Figures 3.1.2-8 and 3.1.2-9 show the measured underwater noise levels collected at site NA3 while these activities were underway around Northstar. The vibrahammer was not in operation at this time but undoubtedly generators and related equipment were in operation.

As has been noted before, the lower hydrophone (H1) exhibits a slightly higher noise environment. Both sensors show strong manmade noises in the sub-10 Hz region, strong tonal presence between 30 and 120 Hz, and significant energy all the way out to 20 kHz when compared to the noise measurements collected near the Liberty site. A second set of underwater measurements is presented in figures 3.1.2-10 (H1) and 3.1.2-11 (H2). These examples were collected during the quietest time period during our data recording effort at this site. In general, the broadband noise level is lower but the narrowband contribution to the noise field is much more evident.

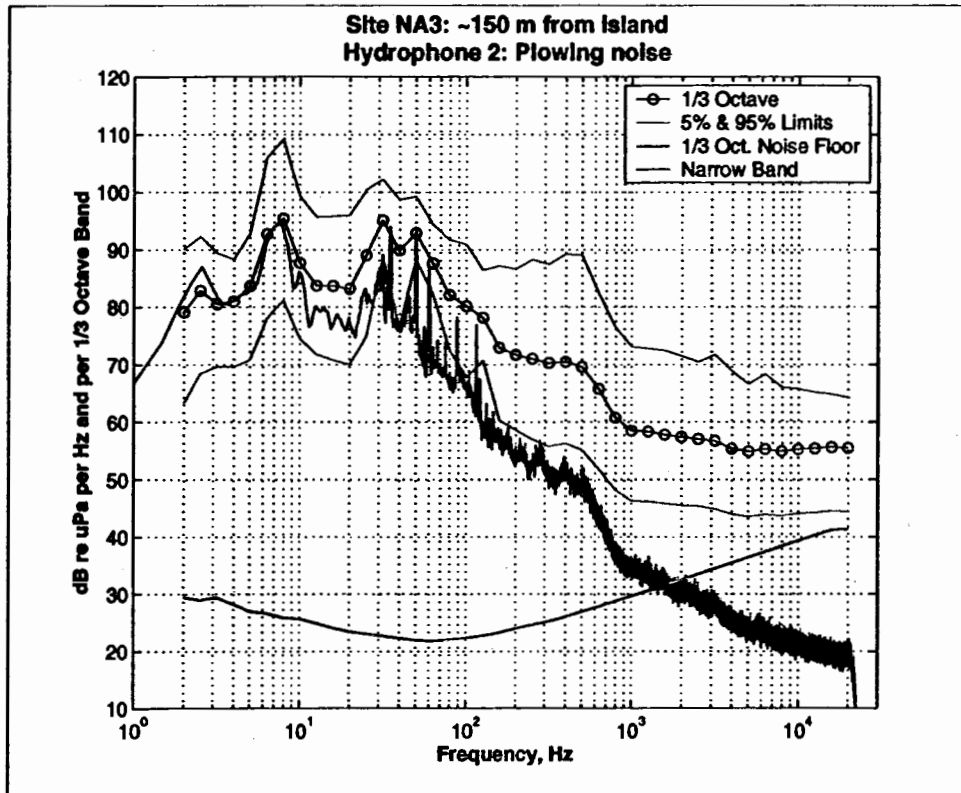
**Figure 3.1.2- 9. Mid channel depth underwater noise at Site NA3, plowing (8-8100).**

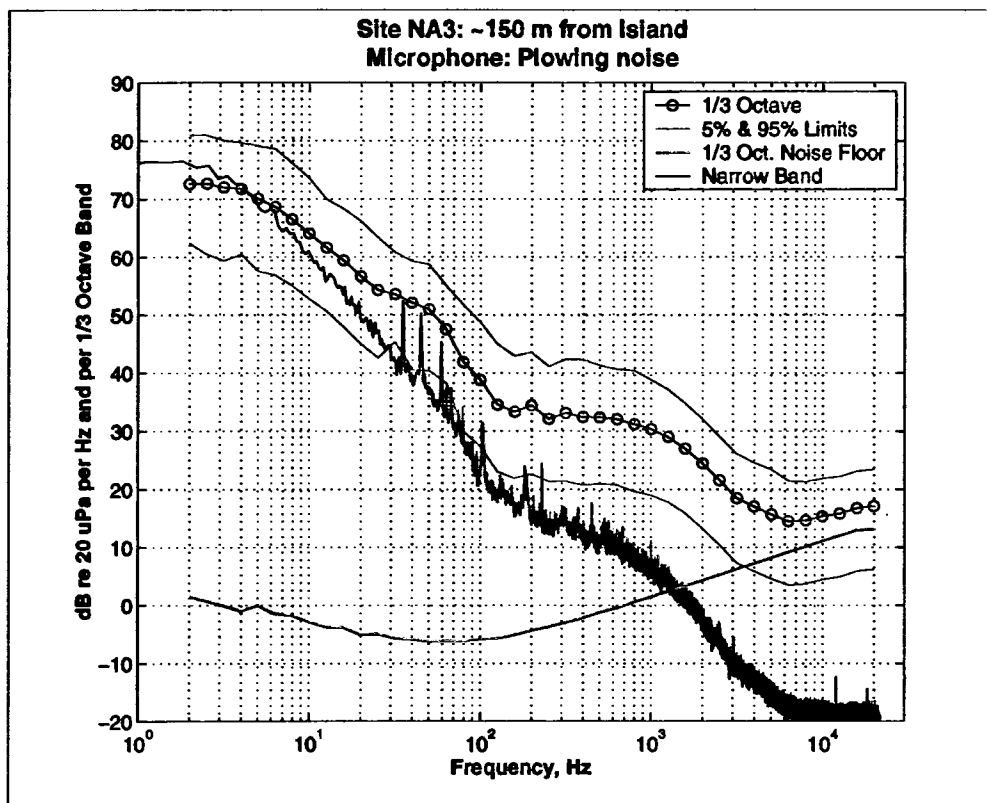
**Figure 3.1.2- 12. Airborne noise at Site NA3; plowing (3-8100).**

Two examples of the in-air noise environment at NA3 when the vibrahammer is not operating are shown in figures 3.1.2-12 and 3.1.2-13. Manmade noise dominates the airborne noise environment at all frequencies below about 6 kHz. As in the water below, numerous narrowband tonals produced by nearby machinery are a significant feature.

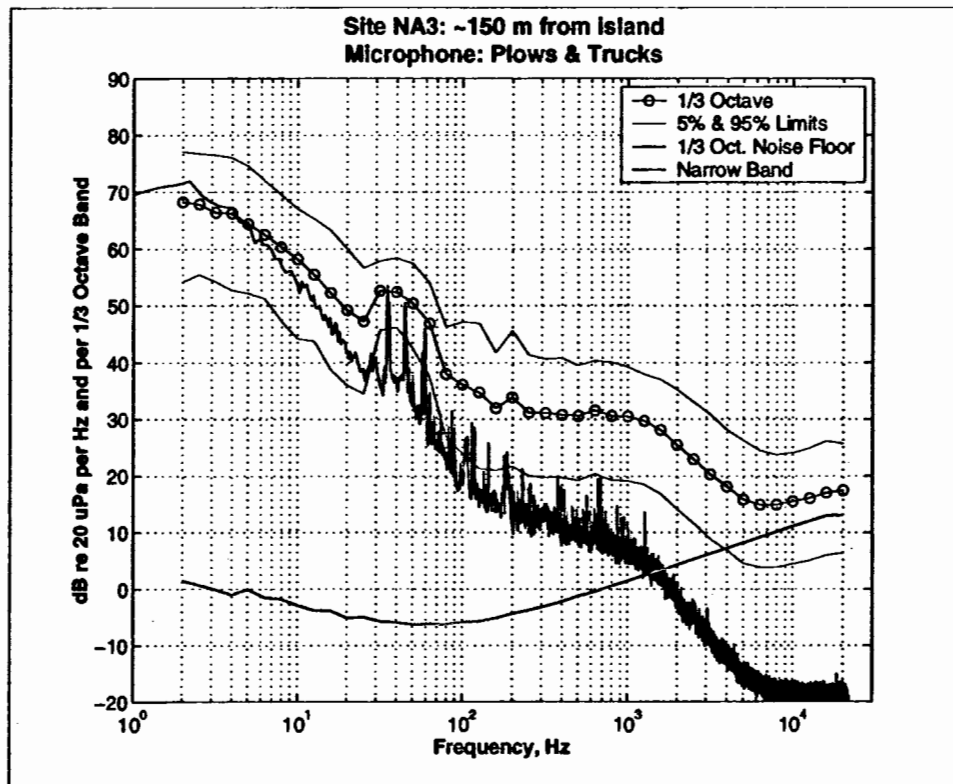
**Figure 3.1.2- 13. Second example of airborne noise at Site NA3 (3-2500).**

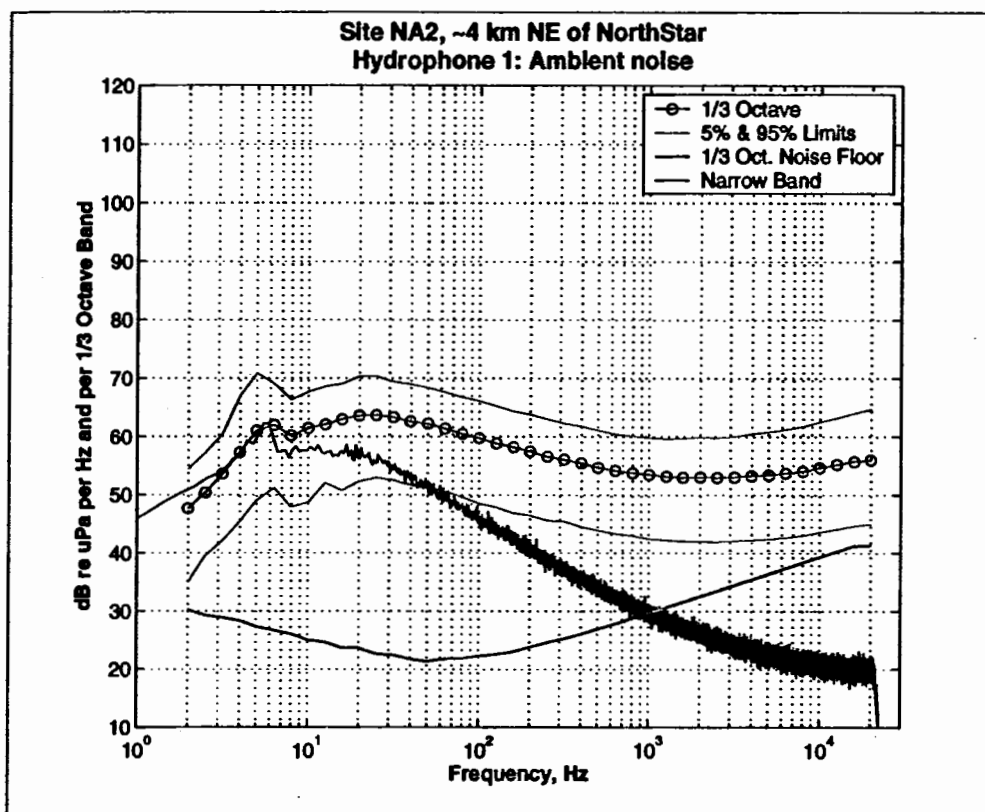
Figure 3.1.3- 1. Near bottom underwater noise at site NA2. (4-4000)

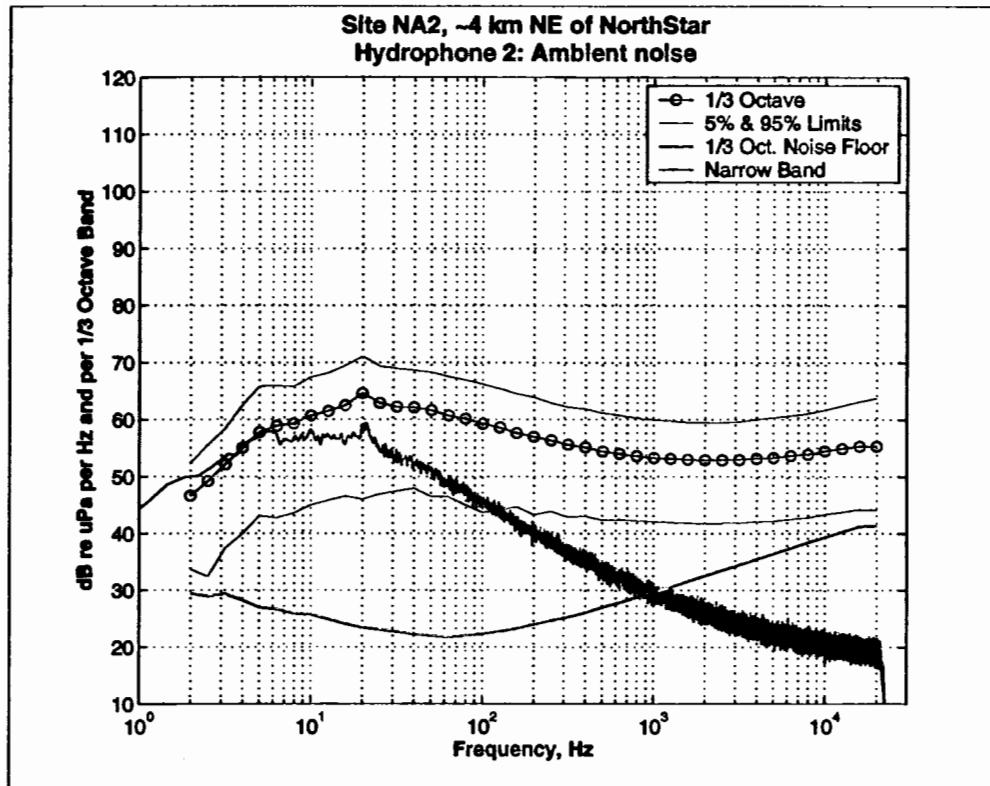
Figure 3.1.3- 2. Mid channel underwater noise at site NA2. (4-4000)

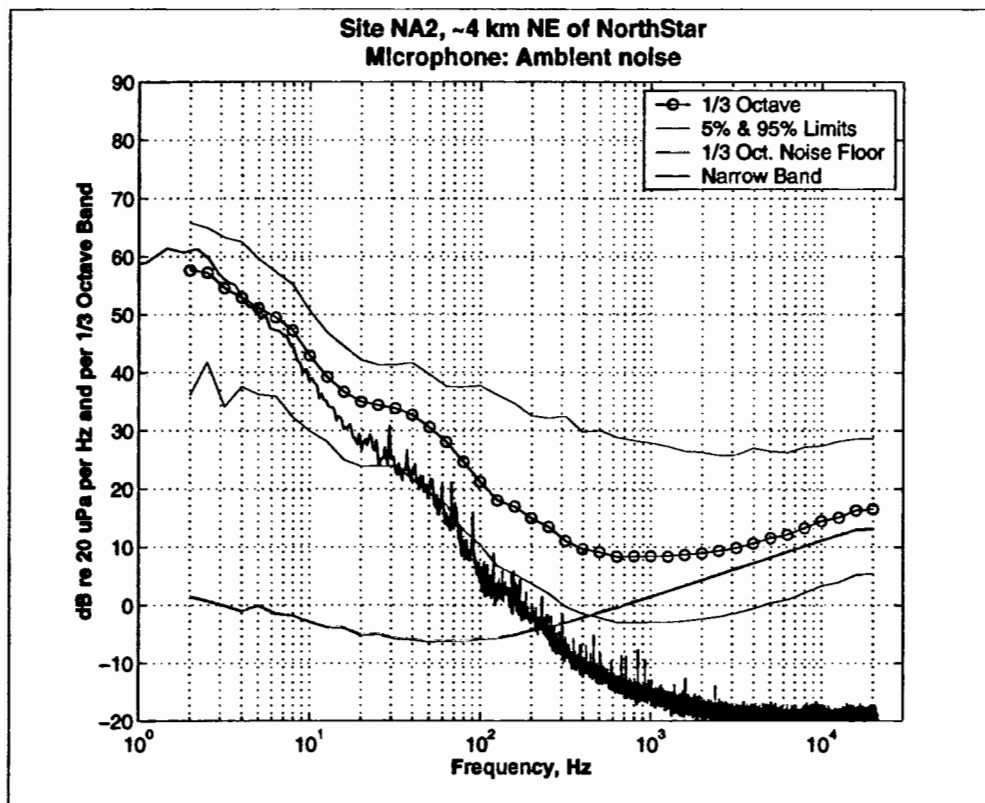
Figure 3.1.3- 3. Measured in-air noise levels at site NA2. (4-4000)

The in-air noise at site NA2 was very quiet. Winds were light and ice cracking noise was not detected aurally. Figure 3.1.3-3 shows a sample spectrum. While a few narrowband lines are present, the levels represent very quiet conditions.

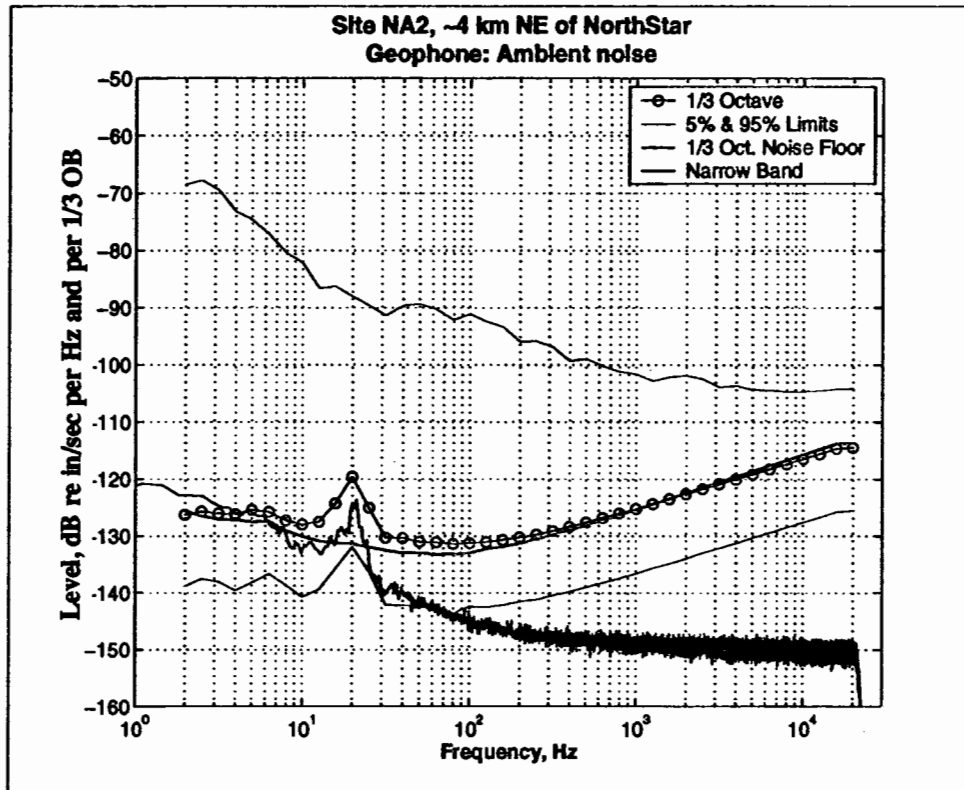
Figure 3.1.3- 4. Measured ice vibration levels at site NA2. (4-4000)

Ice vibration noise is shown in Figure 3.1.3-4. The only spectral region with valid data above system noise is in the band from 12 to 18 Hz. This appears to be the same peak observed with the mid water hydrophone and is probably generated in the ice.

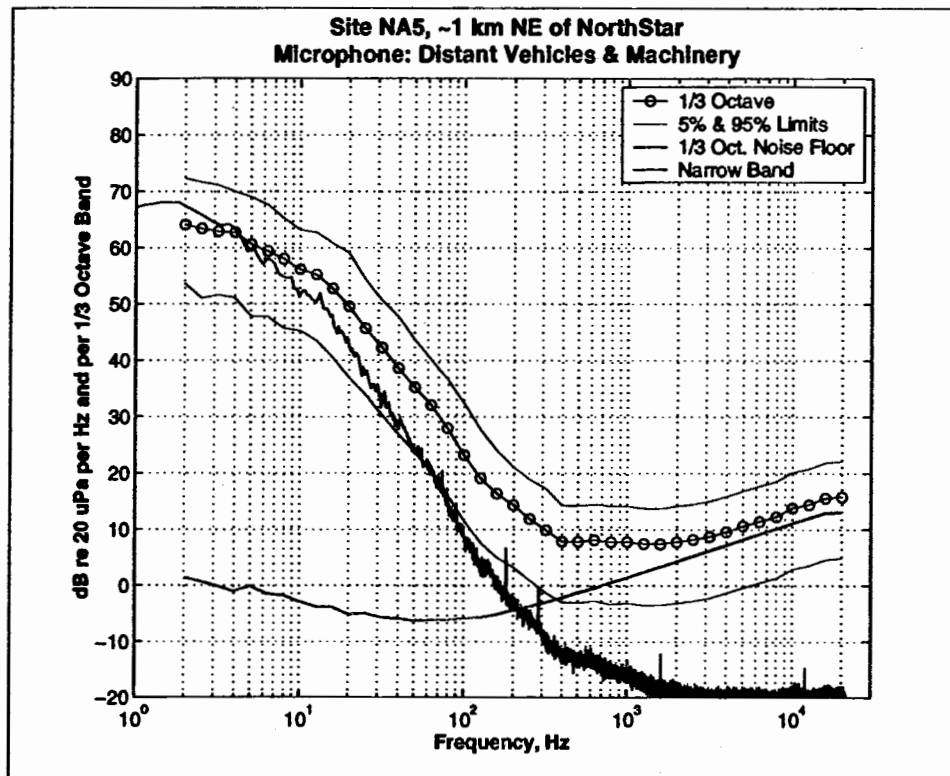
Figure 3.1.4- 3. Measured in-air noise levels at site NA5; lunch break. (8-4400)

The airborne noise spectra recorded during the lunch break is shown in Figure 3.1.4-3. Again comparing these conditions to the quiet period at site LA2, the only manmade, i.e., machinery, sounds above ambient at this site are at frequencies below 80 Hz. At 80 Hz

the two sites had equal levels. The difference increases as frequency decreases so that at 2 Hz the site NA5 levels are nearly a 15 dB higher than measured at LA2. Also note that the microphone picked up a few tonals, notably at about 180 and 290 Hz. When work resumes, these tonals are masked by the site crew at work as discussed below.

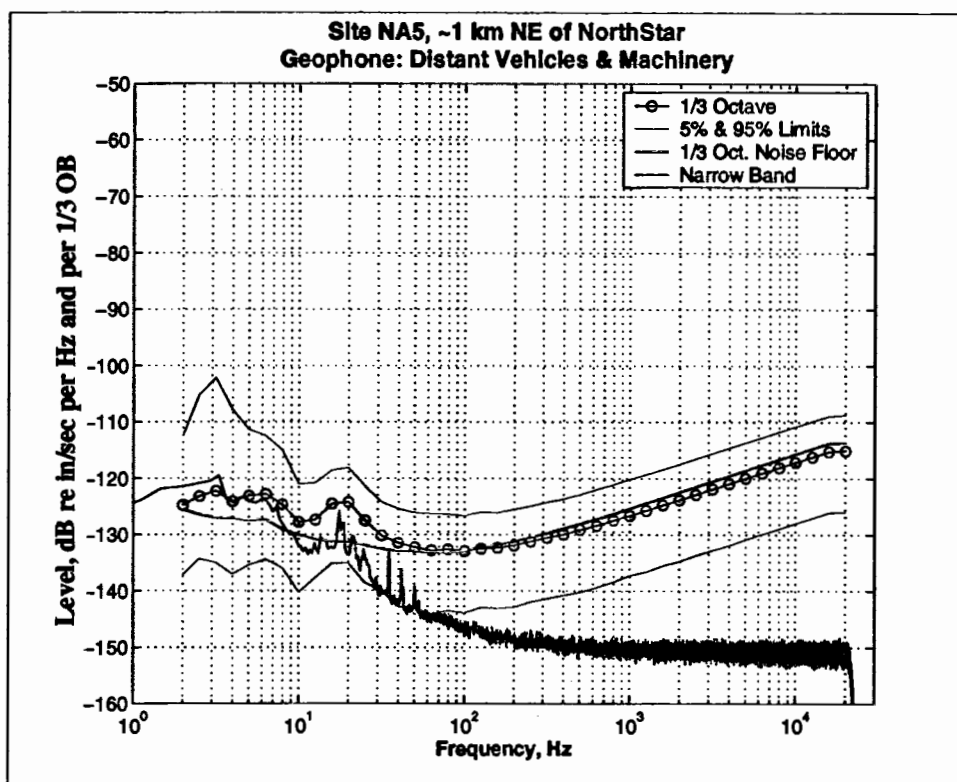
Figure 3.1.4- 4. Measured ice vibration levels at site NA5; lunch break. (8-4400)

Ice vibration levels 0.54 nm (1 km) away from Northstar at lunch time are shown in Figure 3.1.4-4. The only energy detectable above the measurement system noise floor is below about 30 Hz and includes three of the tonals observed in the underwater data set discussed above.

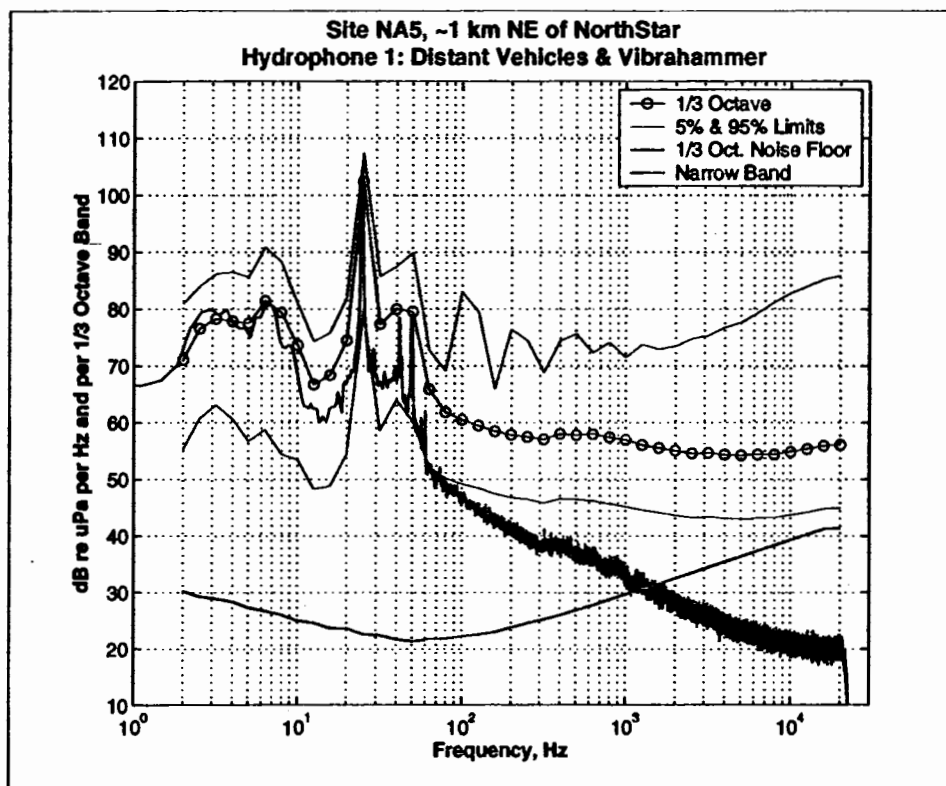
Figure 3.1.4- 5. Near bottom underwater noise levels at site NA5; vibrahammer. (8-1200)

Underwater noise from the two sensors during moderate vibrahammer excitation are shown in Figures 3.1.4-5 and 3.1.4-6 for the deep and mid channel hydrophones, respectively. The dominant features are the tonal near 23 Hz, the high energy below 10 Hz, and a few tonals above the strong 23 Hz peak. As before, the near bottom sensor has slightly more noise than the mid-channel sensor. Under moderate vibrahammer noise, the 1/3 OB containing the 23 Hz tonal was seen to vary in level from 96 to 106 dB re  $\mu\text{Pa}$  on H1 and 92 to 102 dB re  $\mu\text{Pa}$  on H2. Over the rest of the spectral band, the noise spectra levels remained quite consistent ( $\pm 2$  dB).
